Prepared for the 60th Annual Forum and Technology Display sponsored by the American Helicopter Society Baltimore, Maryland, June 7–10, 2004

Investigation of Gear and Bearing Fatigue Damage Using Debris Particle Distributions

ABSTRACT

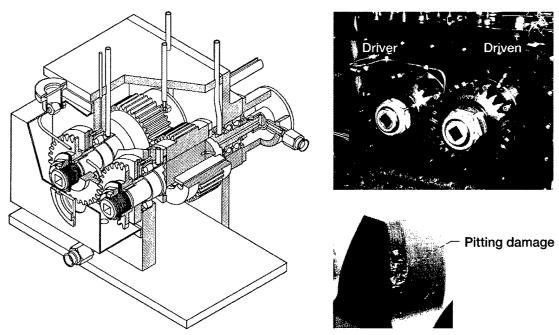
Figure 1.—Spur gear fatigue test rig.

failures occurred during testing. Pitting is a fatigue failure caused by exceeding the surface fatigue limit of the gear material. Pitting occurs when small pieces of material break off from the gear surface, producing pits on the contacting surfaces [11]. Gears were run until destructive pitting occurred on one or more teeth, where pits are greater than 0.4 mm diameter and cover more than 25 percent of tooth contact area. A gear tooth with the fatigue failure under study is shown in Figure 1. Note the damage is shown on less than half of the tooth due to the offset testing discussed above.

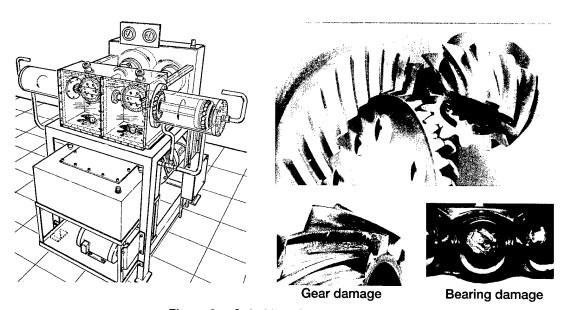
Figure 2.—Spiral bevel gear fatigue rig.

A representative example of the damage observed on the pinion during spiral bevel gear testing is shown in Figure 2. Pitting damage to the pinion occurred during all experiments. However, during one experiment, bearing damage also occurred. This is also shown in Figure 2.

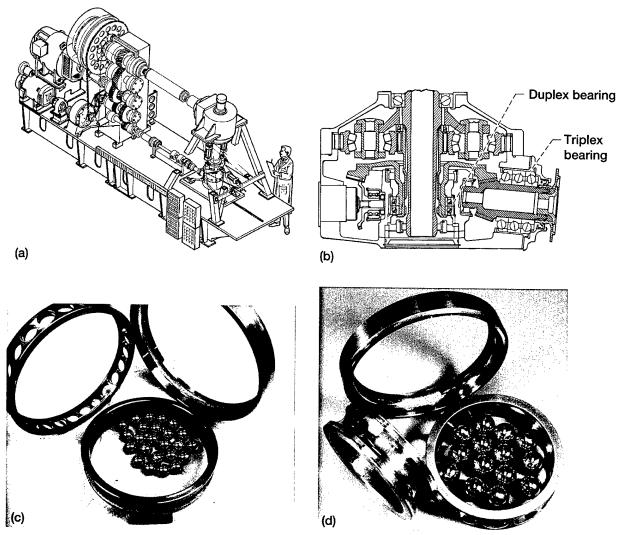
After 33 hours of run time, the transmission was disassembled and a spalled spiral-bevel gear duplex ball bearing was found (Figures 3b and 3c). A new bearing was installed and the transmission was cleaned and re-assembled. After an additional 39 hours of run time, the transmission was disassembled and a spalled spiral-bevel pinion triplex ball bearing was found (Figures 3b and 3d).

Figure 3.—500 hp helicopter transmission test stand. (a) Rig schematic. (b) OH-58C main rotor transmission. (c) Failed spiral-bevel gear duplex ball bearing. (d) Failed spiral-bevel pinion triplex ball bearing.

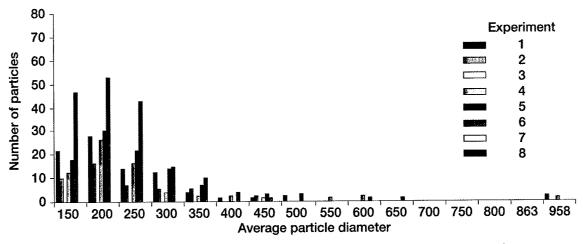
Figures 4, 5 and 6 are histograms of the number of particles for each average particle size diameter for Experiments 1 through 17. Figure 4 is the data before damage was observed. Figure 5 is the data after pitting damage was observed. The particle counts increased as damage occurred, and particles were detected in more size ranges. However, the distribution was very similar before and after damage. Figure 6 shows the data collected during experiments without damage. The particle size distribution of the debris is also very similar to the other two figures.

Figure 4.—Spur rig experiments with damage, prior to damage observed.

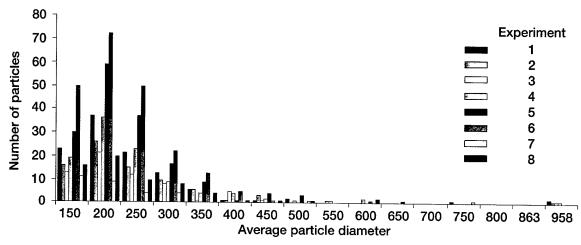
Figure 5.—Spur rig experiment after pitting damage was observed.

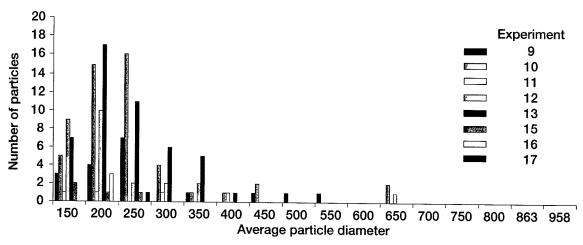
Figure 6.—Spur rig experiments with no damage.

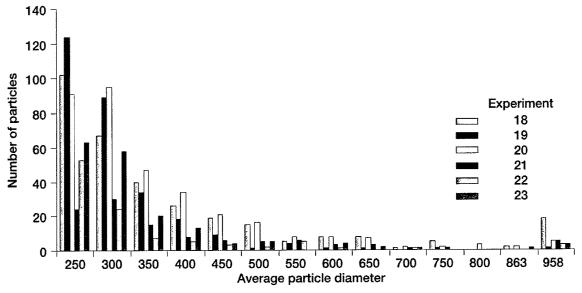
Figures 7 and 8 are histograms of the number of particles for each average particle size diameter for Experiments 18 through 23.

Note only 14 particle size ranges were measured, as compared to 16 during Spur Rig experiments. Also note the smallest average particle diameter measured was 250 microns. Although the counts are higher than the counts measured during Spur Rig experiments, the distribution is also very similar to the spur rig experiments both with and without damage.

Figure 7.—Spiral bevel rig experiments with pitting damage.

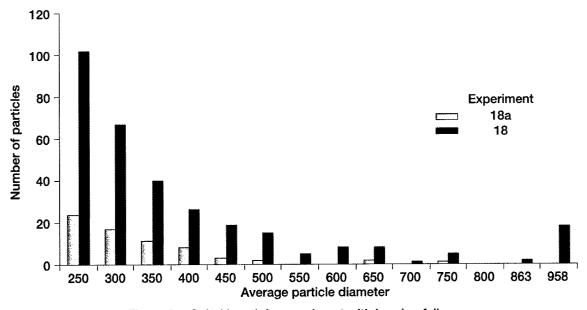
Figure 8.—Spiral bevel rig experiment with bearing failure.

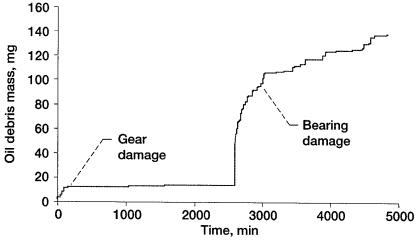
Figure 9 is from the Spiral Bevel Rig Experiment 18 with both gear and bearing damage. The gears were inspected at reading 99 and initial pitting was beginning to occur on the right side of the test rig. The gears were inspected at test completion and destructive pitting to one tooth on the right side pinion was observed and is shown in Figure 2. At test completion, it was found that damage also occurred on the pinion bearing. This damage is also shown in Figure 2. It is believed that the pinion bearing initiated pitting damage at reading number 2592 due to the drastic change in accumulated mass from Figure 9. The legend label Exp. 18a in Figure 8, refers to the count data taken during Experiment 18 prior to bearing failure occurred, but pitting damage was observed on the pinion (Reading 2592). The counts increased significantly when bearing damage occurred, but the distribution is very similar to that of gear pitting damage particle distributions.

Figure 9.—Damage to right pinion gear and bearing during experiment 18.

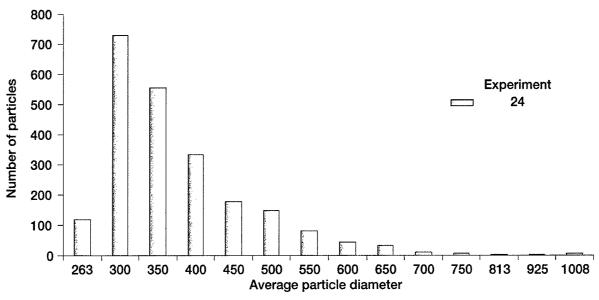
Two experiments, identified as Experiments 24 and 25, were performed in the 500-hp Helicopter Transmission Test Stand. Table 8 lists the total number of readings for each experiment and the amount of wear debris at test completion. Mean particle size was also calculated for the final reading for each experiment. Results of this calculation are also shown in Table 8. As stated before, a spalled spiralbevel gear duplex ball bearing was found at the end of Experiment 24. For Experiment 24, a large increase in debris occurred at reading number 2755. This also coincided with the test transmission chip detector indication of debris. After reading 2755, an exponential increase in accumulated debris occurred. At the end of the test, over half of the bearing inner race, over half of the outer race, and most of the balls were damaged (Figure 3c). Figure 10 is a histogram of average particle size for the end of Experiment 24.

For average particle diameters greater than 300mm, the distribution looks similar to the previous spur and spiral-bevel test rig results.

Figure 10.—500 hp test stand duplex bearing failure.

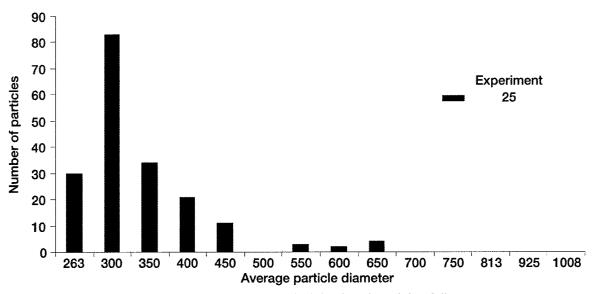
Also as stated before, a spalled spiral-bevel pinion triplex ball bearing was found at the end of Experiment 25. A constant increase in debris occurred during this test. At the end of the test, a small portion of the outer bearing race was damaged (Figure 3d). Figure 11 is a histogram of average particle size for the end of Experiment 25. The distribution is similar to that of the spiral-bevel gear duplex ball bearing failure.

Figure 11.—500 hp test stand triplex bearing pinion failure.
